Limited Visual Dam Safety Inspection Summary Report

MA-078

Reservoir 42

May 2006

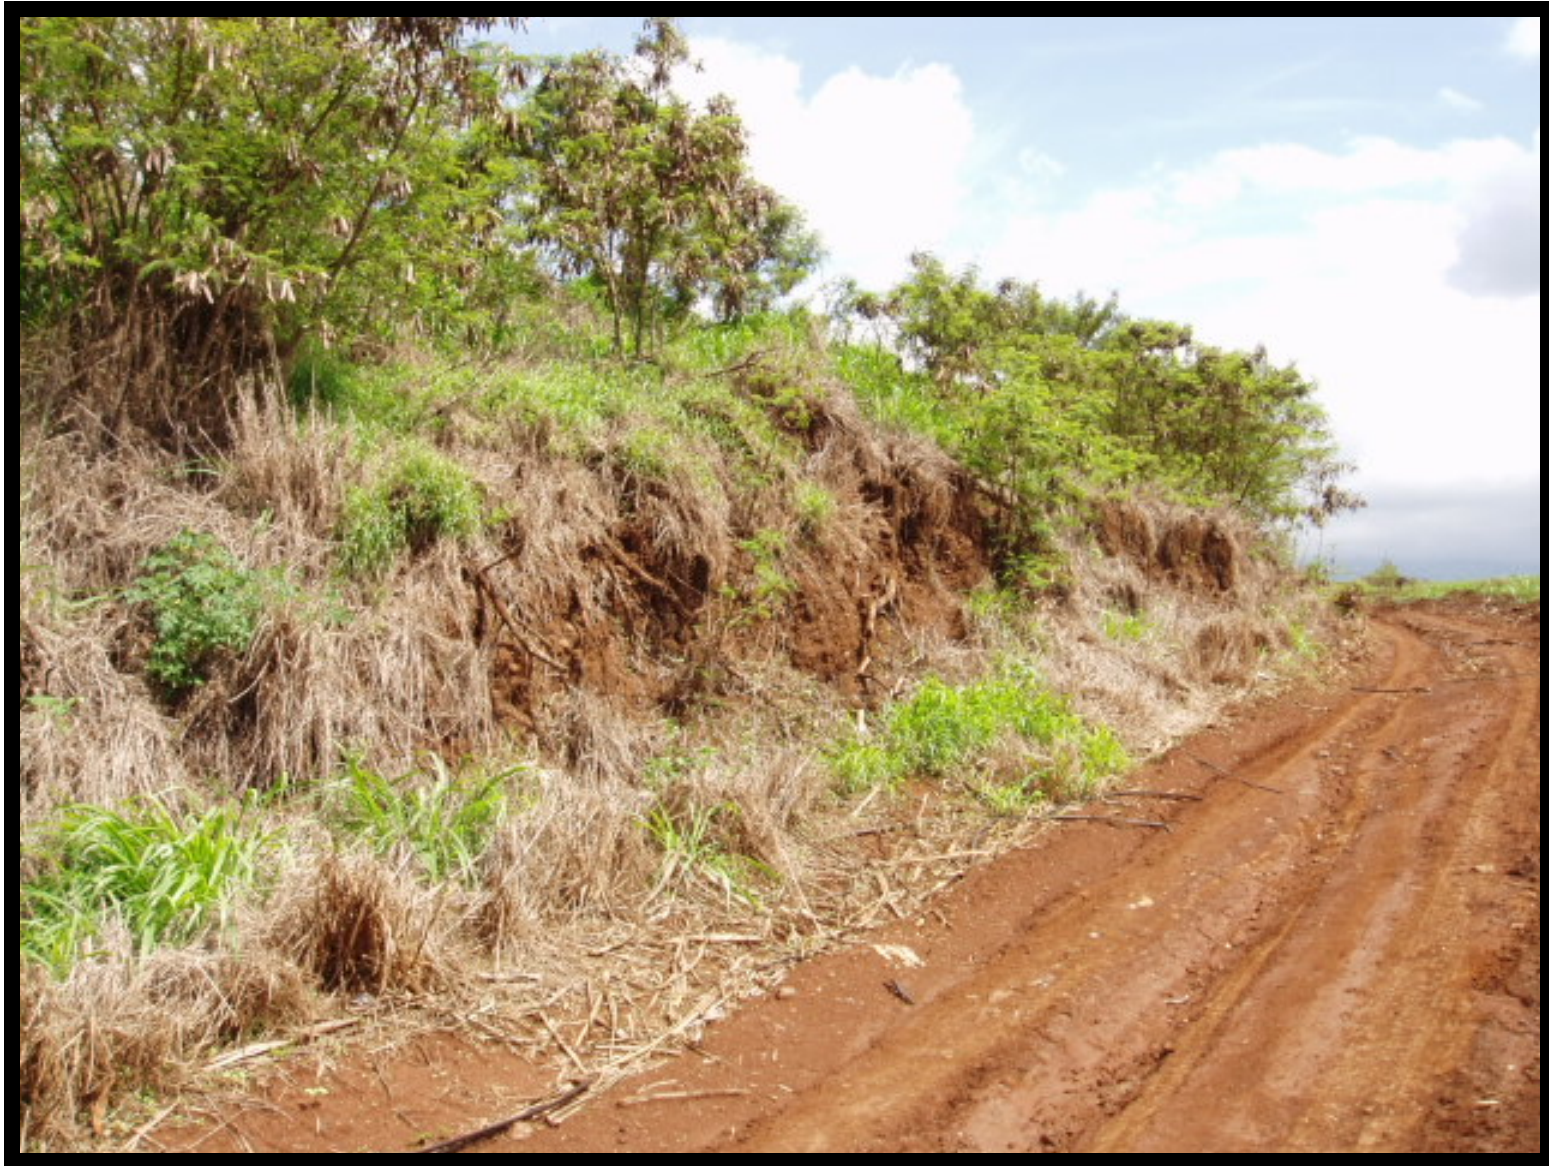
The downstream slope was approximately 1 on 1.

Dense vegetation made inspection of the slope difficult.

- a. The downstream slope appeared to be in fair to poor condition and requires corrective action.
- b. The down stream slope was not visible due to high grass and bush vegetation. Clear high vegetation and maintain low to enable easy visual inspection.

- d. The slope was very steep, around a 1 to 1 slope; further study is required to verify slope stability.
- e. There was near vertical slop on the lower downstream slope. Vertical slope about 5' high. Could be from the toe road being cut into embankment. Slope should be flattened.

078 Downstream slope of the dam. The very steep lower slope (near vertical) should be flattened

- c. Tree(s) were observed on the downstream slope. Trees have been identified as the probable cause of piping failures, and can possibly cause severe damage to the embankment if they are uprooted during high winds. Corrective action is required to remove the tree hazards from the dam. Acceptable remedies include removal of the tree and its root structure down to a 2" diameter and reconstruction the damaged embankment section. All repair work shall be accomplished as per the requirements of licensed geotechnical or structural engineer. Routinely monitor the damaged area for signs of settlement and seepage.

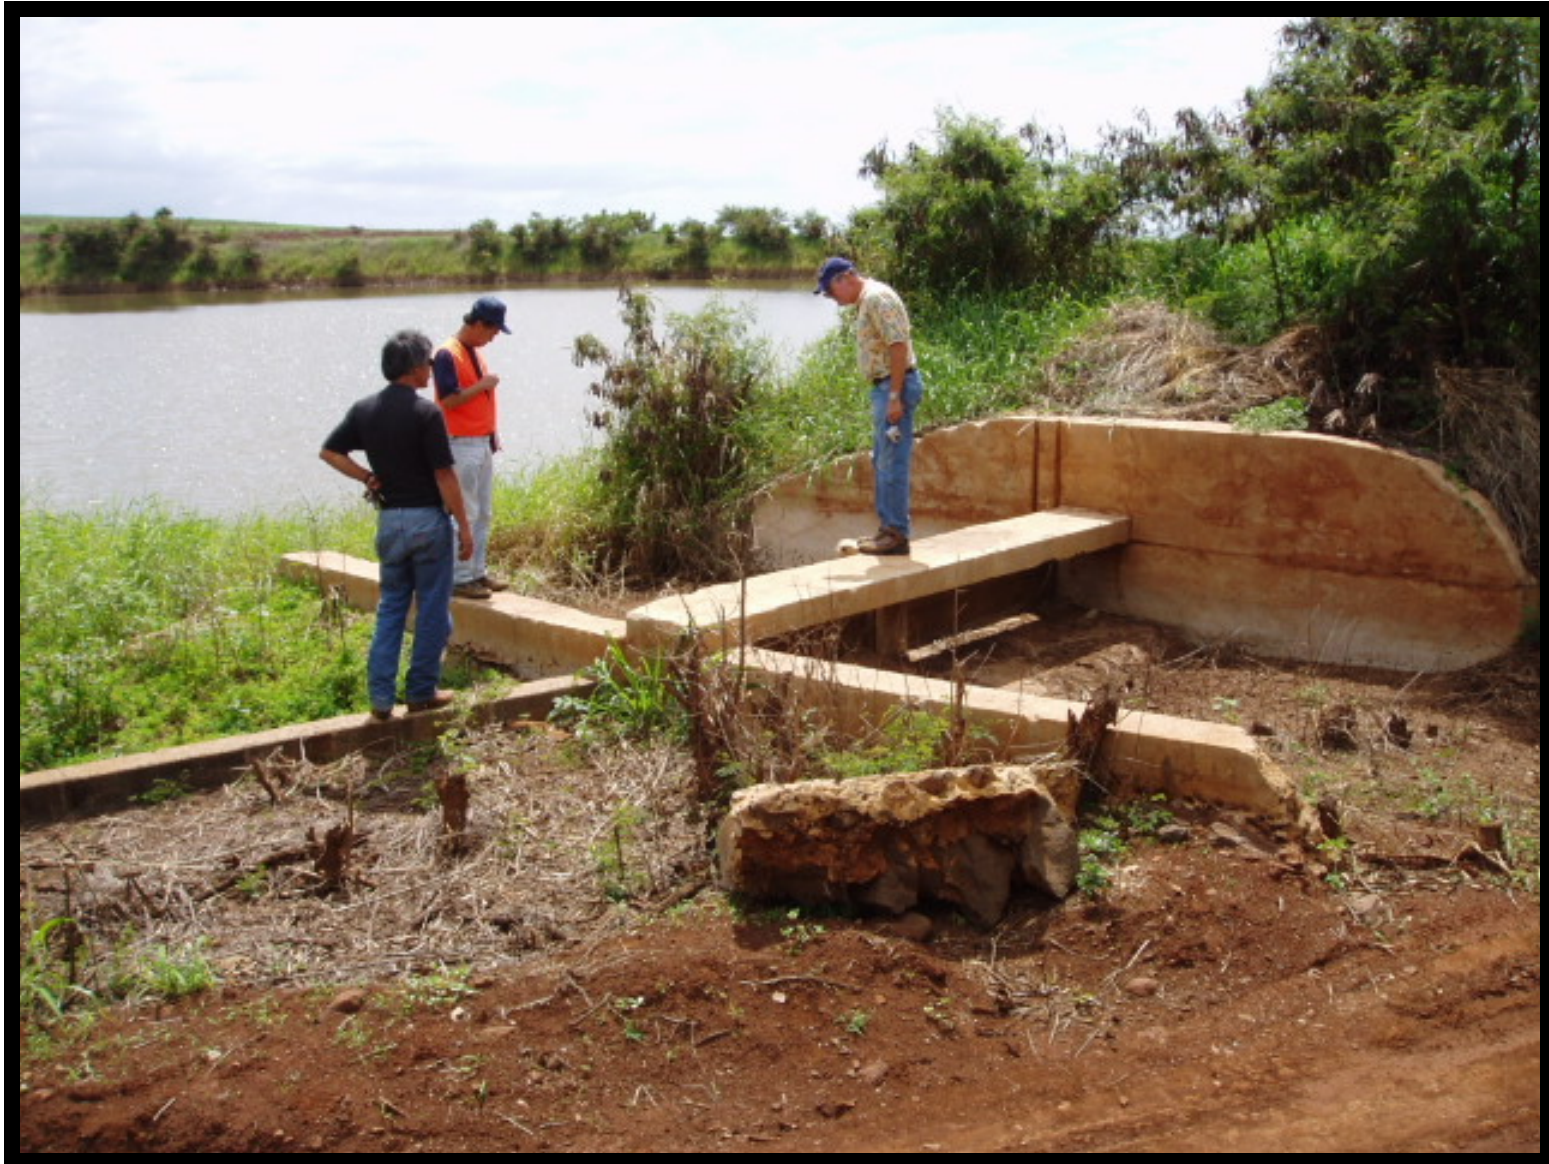
This spillway is consisted of a channel.
The dimension is 14.5 feet and the invert elevation is 765 feet NGVD.
The spillway approach was clear.
Erosion was not observed at the time of inspection.

- a. The Spillway appeared to be in satisfactory condition, no corrective actions are required at this time.

078 spillway

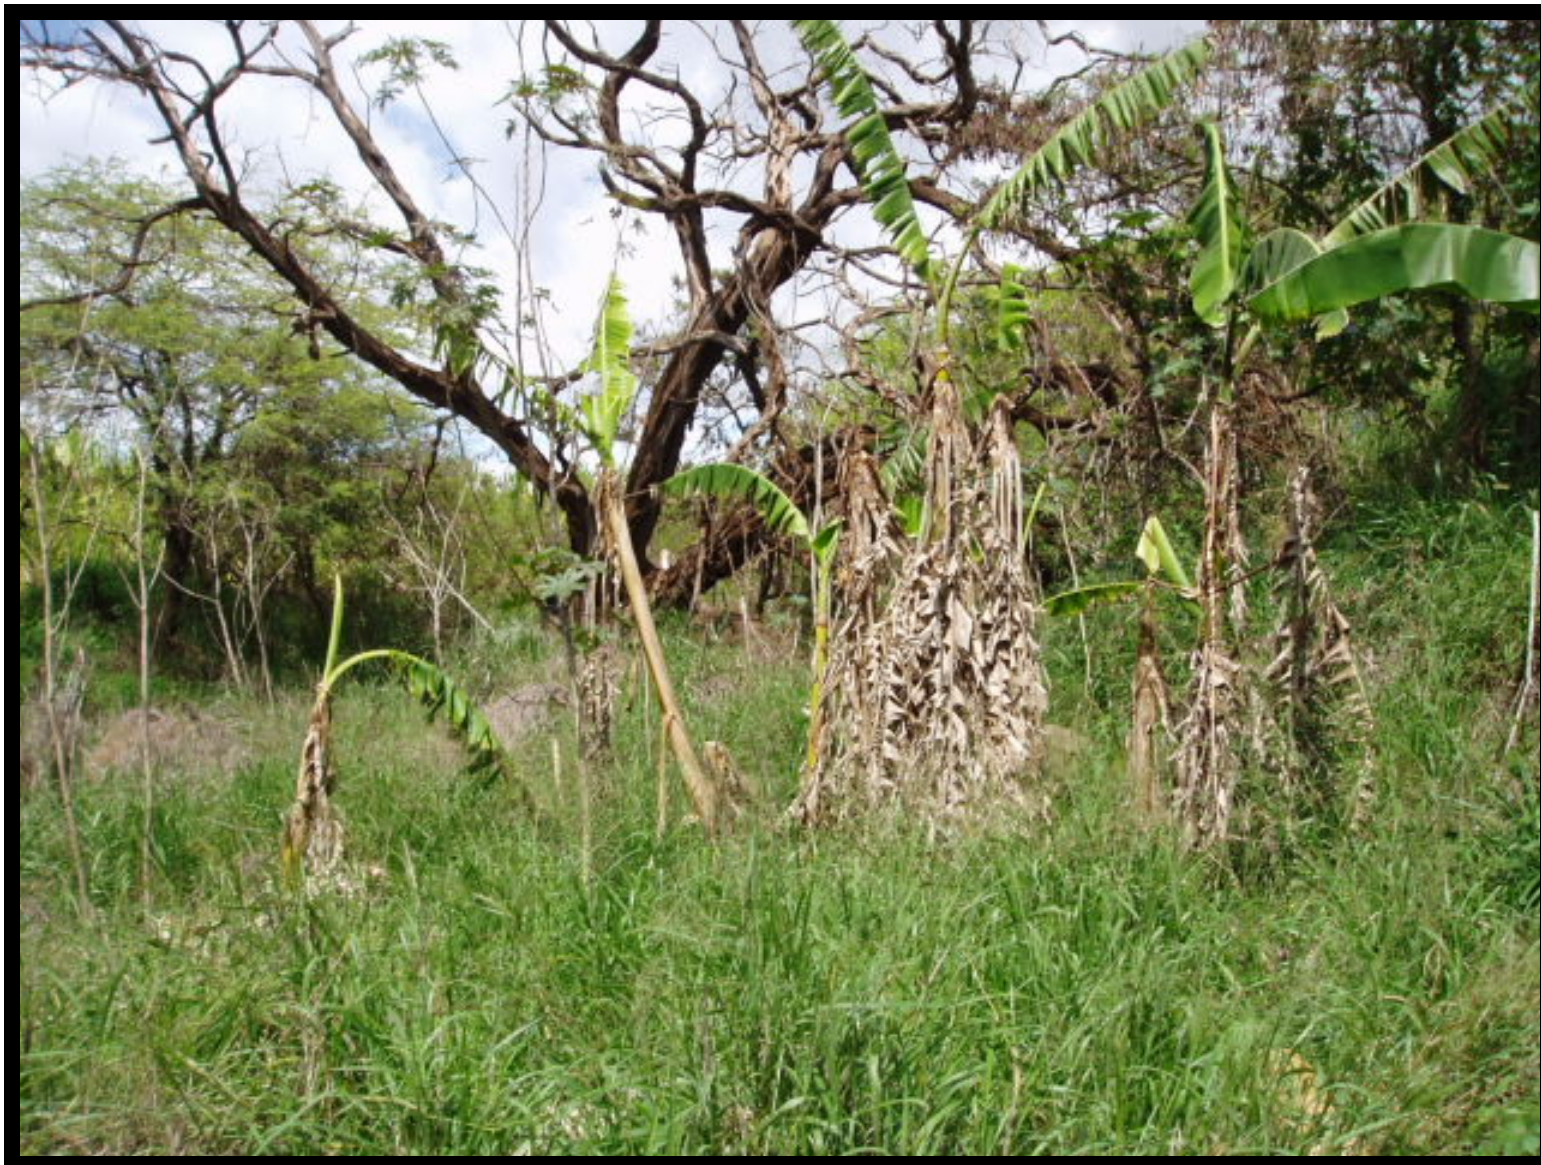
Dense vegetation on the right side of outlet works made inspection impossible.
Vegetation to the left of outlet works is acceptable.

- a. The abutments/toe appeared to be in fair to poor condition and requires corrective action.
- b. The abutment/toe area was not visible due to high grass and bush visual inspection. Clear high vegetation and maintain low to enable easy visual inspection.
- c. Tree(s) were observed along the abutment/toe. Trees have been identified as the probable cause of piping failures, and can possibly cause severe damage to the embankment if they are uprooted during high winds. Corrective action is required to remove the tree hazards from the dam. Acceptable remedies include removal of the tree and its root structure down to a 2" diameter and reconstruction the damaged embankment section. All repair work shall be accomplished as per the requirements of licensed geotechnical or structural engineer. Routinely monitor the damaged area for signs of settlement and seepage.

078 Dense vegetation along the downstream toe of the dam right of the outlet works.

Underbrush and trees should be removed from the embankment, abutments, and toe areas. Grasses should be kept short.

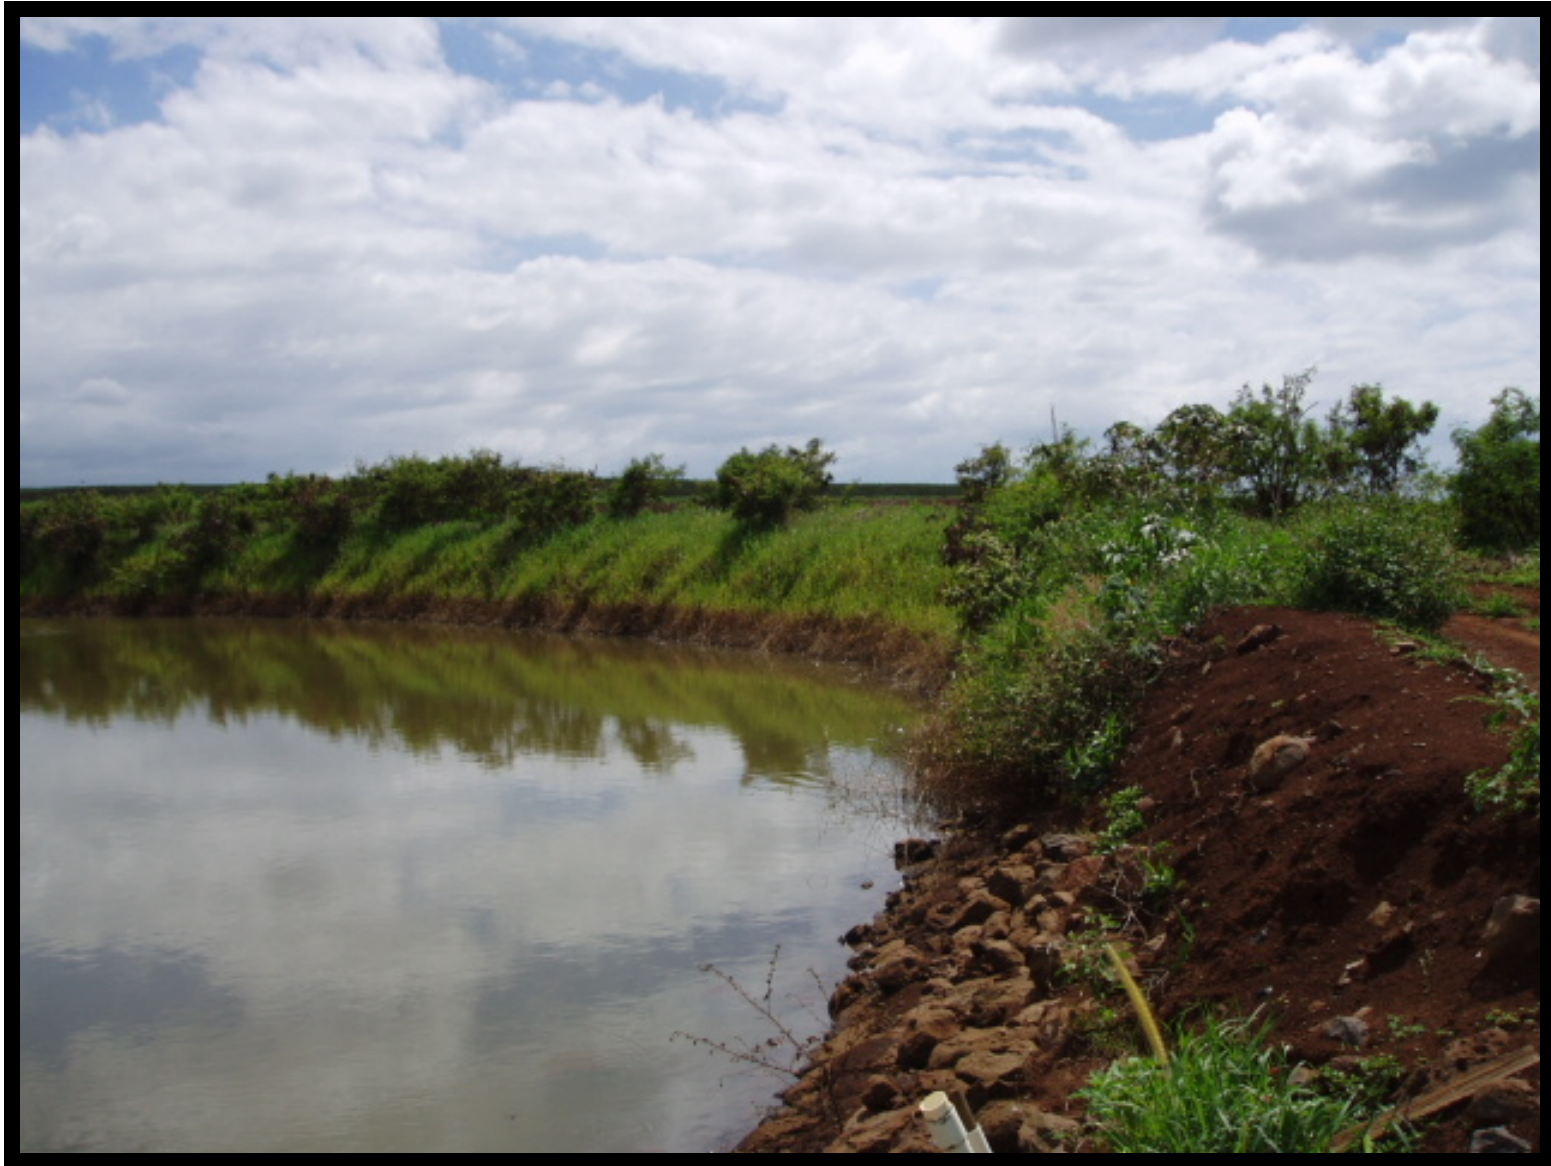
The upstream slope is protected by dumped rock.

There was 12" tall grass above the reservoir pool. Inspection of slope above pool was difficult due to the vegetation.

- a. The upstream slope appeared to be in fair to poor condition and requires corrective action.
- b. The upstream slope was not visible due to high grass and bush vegetation. Clear high vegetation and maintain low to enable easy visual inspection.

078 Upstream slope of the dam. Note tall grass on the slope.
